Subject: The Goodyear Tire & Rubber Company - Pasadena, Texas
TNRCC Solid Waste Registration No. 30316
EPA ID No. TXD074185141
Interim Status Hazardous Waste Unit - Aeration Pond Closure File
LAW Project 50521-6-8800

**THIRD QUARTER GROUNDWATER MONITORING REPORT &
SUMMARY of ANNUAL MONITORING**

Subject: **Response to the Technical Notice of Deficiency for Closure Certification**
(Boiler M-526/Vessel V-411)
The Goodyear Tire & Rubber Company
Bayport Chemical Plant
Pasadena, Texas
LAW Project 60160-0-7301.2

**REVISED REPORT OF
RCRA HAZARDOUS WASTE MANAGEMENT
UNIT CLOSURE**

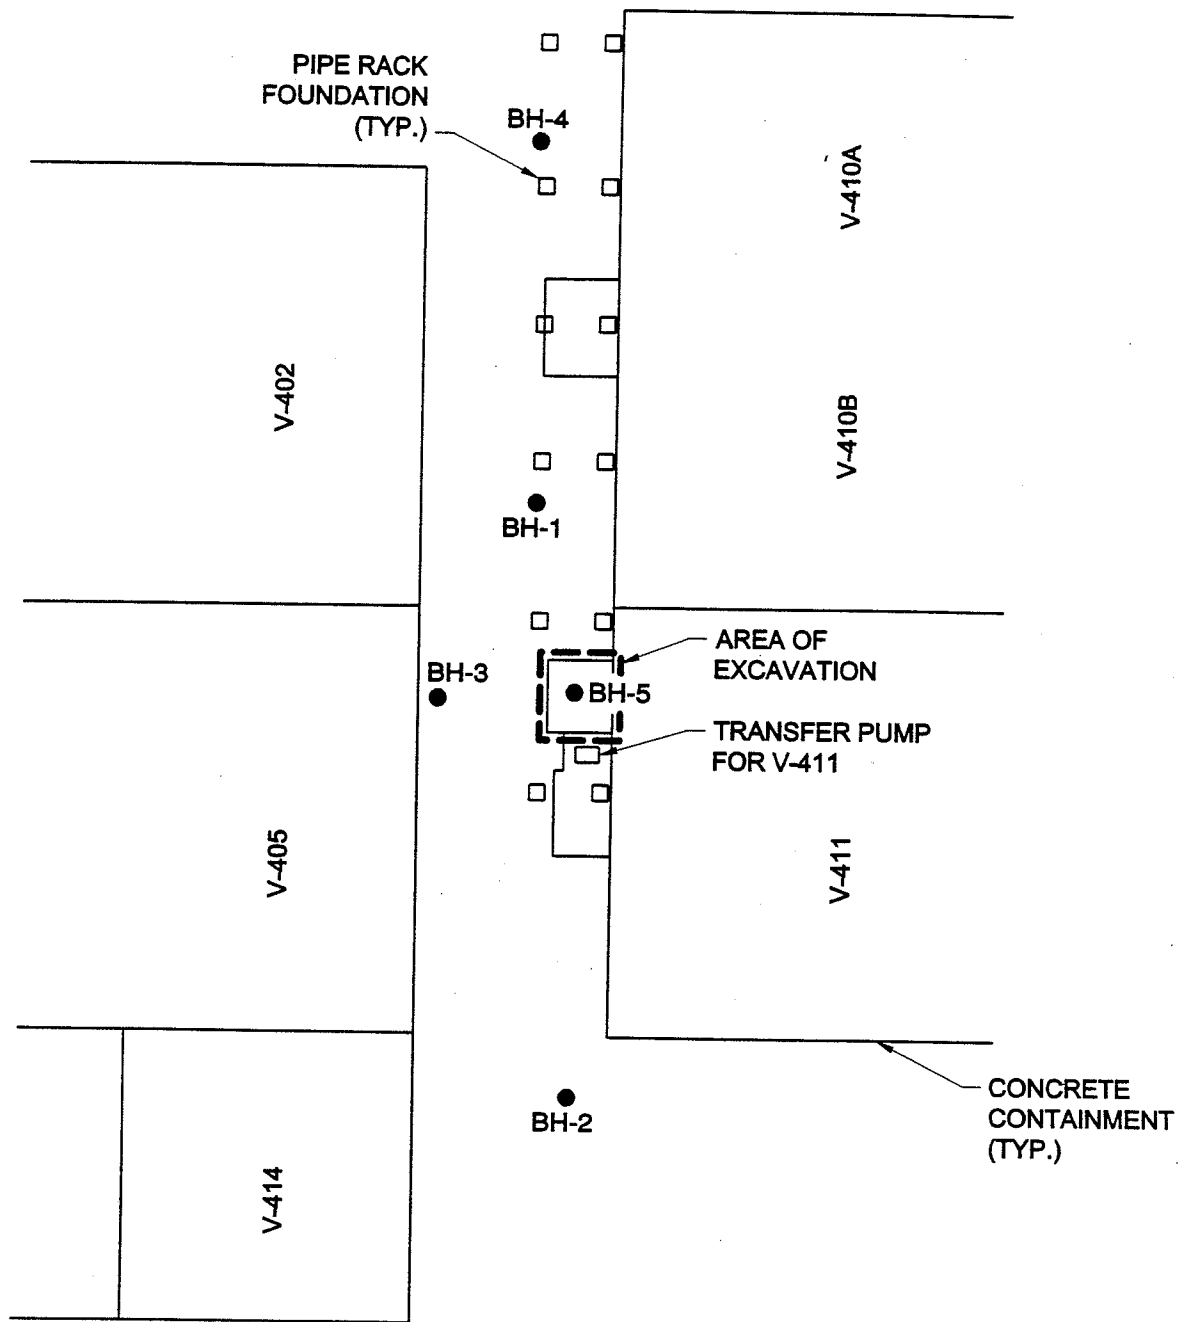
FIGURE 3

SOIL BORING LOCATION MAP
